Knowles (UK) Limited
Chapman Way
Hethel, Norwich, Norfolk
NR14 8FB England

Solder Alloy Choice for Through Hole Ceramic Discoidal & Planar Array Capacitors

Application Note
Reference No: AN0011
Solder Alloy Choice for
Through Hole Ceramic
Discoidal & Planar Array
Capacitors Issue 10

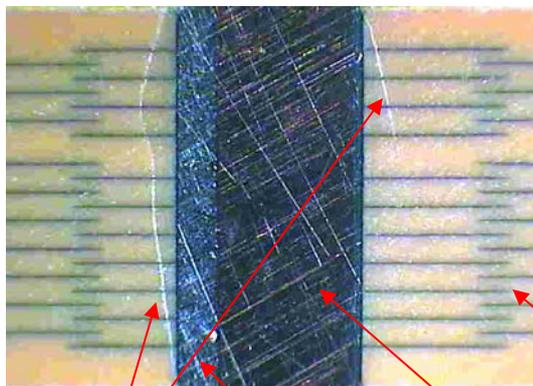
Fig 5

'Longbow Crack'

Capacitor soldered using inappropriate solder alloy. Crack in dielectric material generated during cooling of solder joint after reflow.

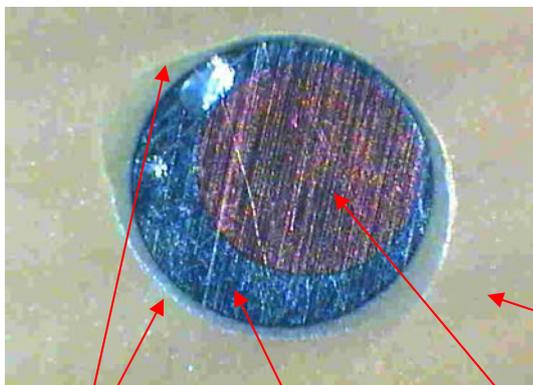
Fig 6

'Comma Crack'

The same crack as in Fig 3 above, but sectioned through a plane 90° displaced.

Cracks in the dielectric material may result in catastrophic electrical breakdown of the capacitor if they propagate through the active electrode area.

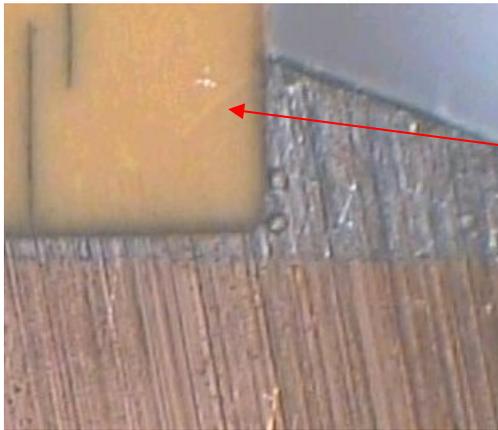
Fig 7

Corner cracking is less critical than longbow / comma cracking and rarely threatens immediate outright dielectric failure, although the induced crack can propagate in operation causing failures. It can be eased by limiting the volume of solder in the meniscus or reducing the pad size. On very small size parts, it is common to remove the pad entirely.

'Corner Crack'

Crack generated by lifting of the pad due to the solder meniscus

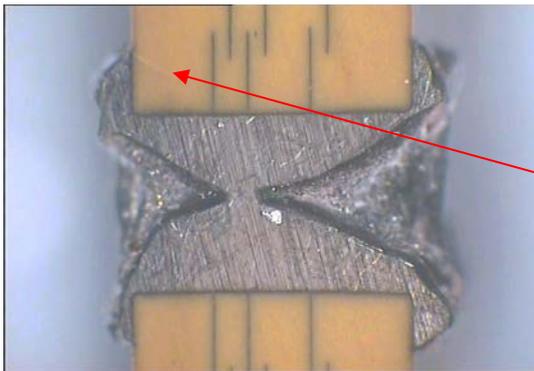
Fig 8

Example of solder joint from which pin has been removed before solder has solidified

Note small corner crack caused by solder meniscus

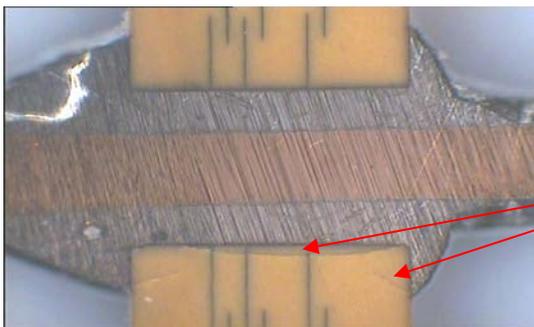
Fig 9

Example of solder joint with pin in place

Note longbow crack and corner cracks

This showed that the cracks only occur during the cooling portion of the soldering profile, and that pins must be present to generate the forces that form the longbow crack. This shows that the forces exerted on the ceramic are external to the capacitor.

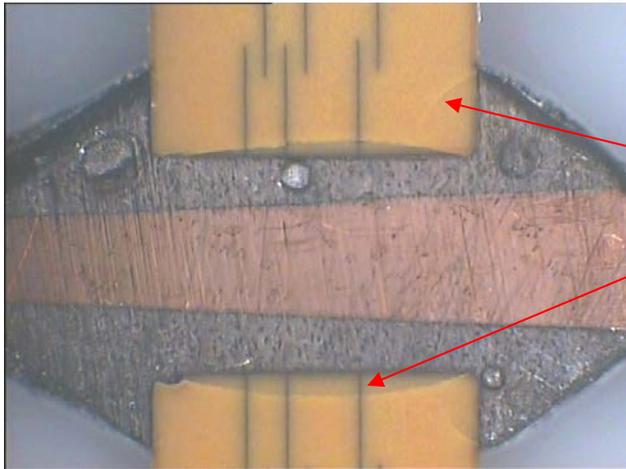
Fig 10

80% of the joints sectioned had longbow cracks adjacent to the solder joint. All the joints inspected had some cracking present in the ceramic, mostly corner cracks..

Example of force cooled
62Sn/36Pb/2Ag solder joint
showing longbow and corner
cracks

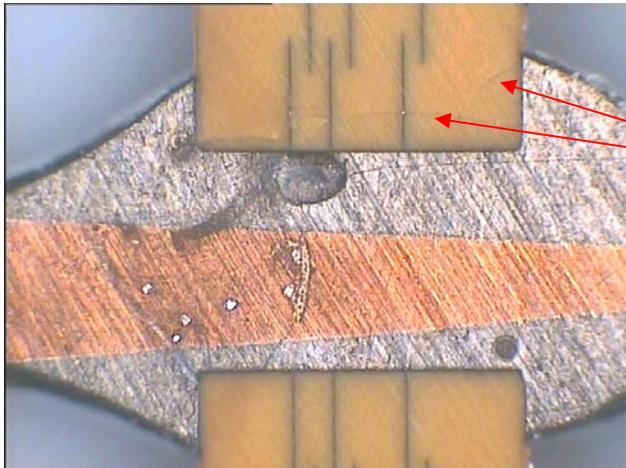
Fig 11

20% of the joints sectioned had longbow cracks adjacent to the solder joint. A total of 60% of joints had corner cracks associated with the solder meniscus.

Example of 62Sn/36Pb/2Ag
solder joint showing
longbow and corner cracks

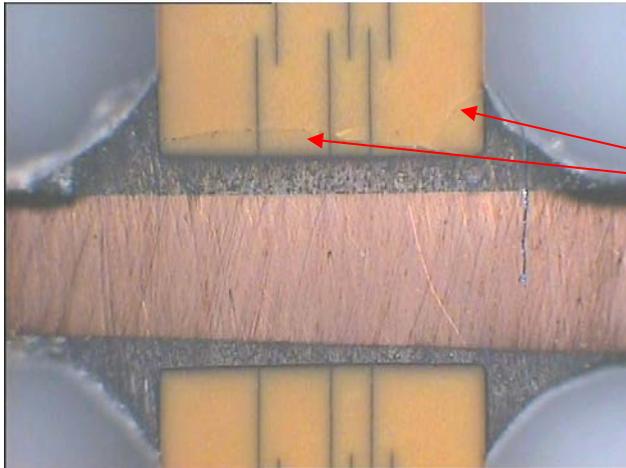
Fig 12

All of the joints sectioned had longbow cracks adjacent to the solder joint. All joints also has corner cracks.

Example of force cooled 60Sn/40Pb solder joint showing longbow and corner cracks

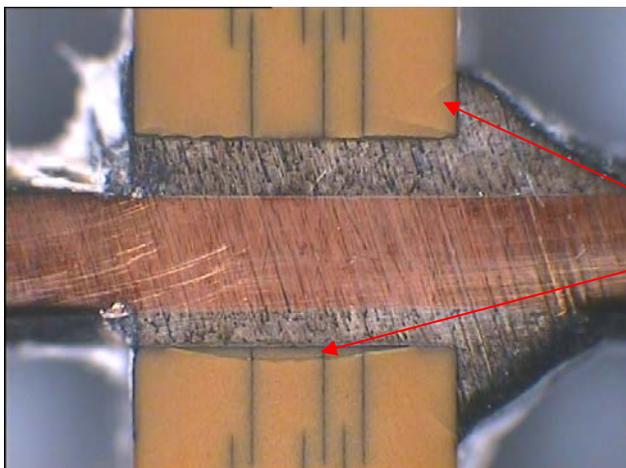
Fig 13

60% of the joints sectioned exhibited longbow cracks adjacent to the solder joint. A total of 80% of joints had corner cracks associated with the solder meniscus.

Example of 60Sn/40Pb solder joint showing longbow and corner cracks

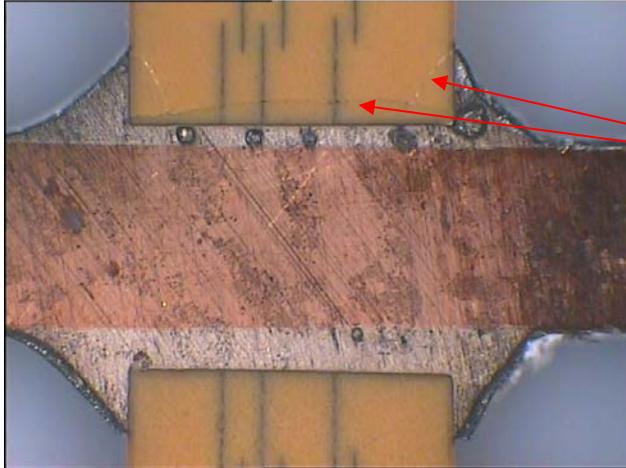
Fig 14

All of the joints sectioned had longbow cracks adjacent to the solder joint. All joints also has corner cracks.

Example of force cooled 99.3Sn/0.7Cu solder joint showing longbow and corner cracks

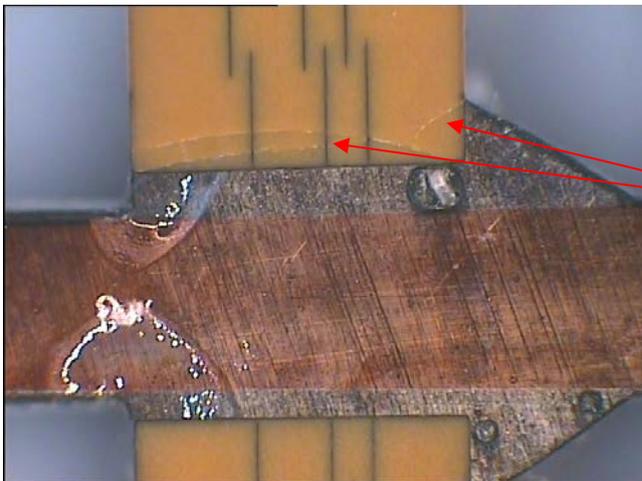
Fig 15

All of the joints sectioned had longbow cracks adjacent to the solder joint. All joints also has corner cracks.

Example of 99.3Sn/0.7Cu solder joint showing longbow and corner cracks

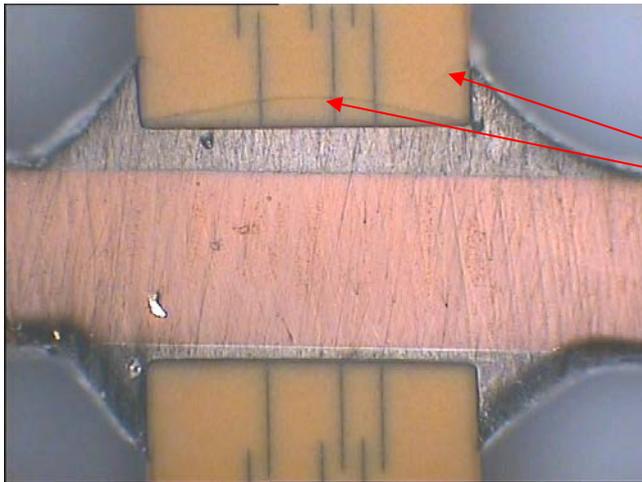
Fig 16

All of the joints sectioned had longbow cracks adjacent to the solder joint. All joints also has corner cracks.

Example of force cooled
95.5Sn/3.8Ag/0.7Cu solder
joint showing longbow and
corner cracks

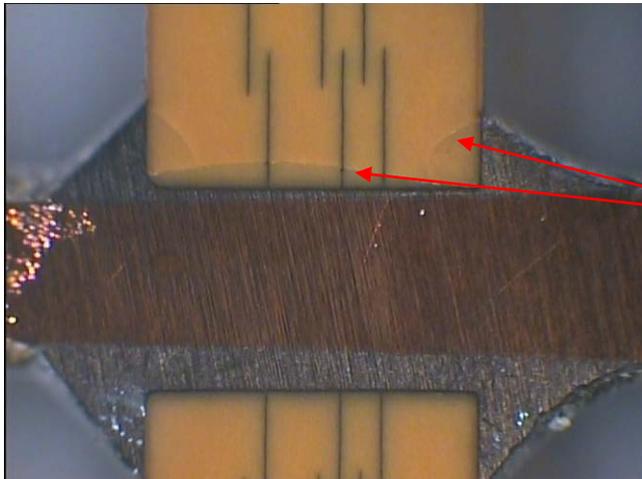
Fig 17

40% of the joints sectioned had longbow cracks adjacent to the solder joint. 80% of the joints in total had corner cracks, mainly corner cracks associated with solder pads.

Example of 95.5Sn/3.8Ag/0.7Cu
solder joint showing longbow and
corner cracks

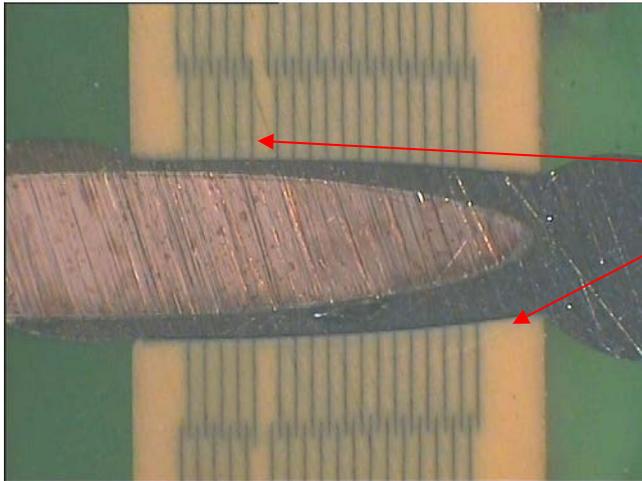
Fig 22

10% of the joints inspected showed very small longbow cracks adjacent to the solder joint. These were noticeably smaller than the cracks seen in other samples.

Example of 93.5Pb/5Sn/1.5Ag solder joint showing small longbow cracks.

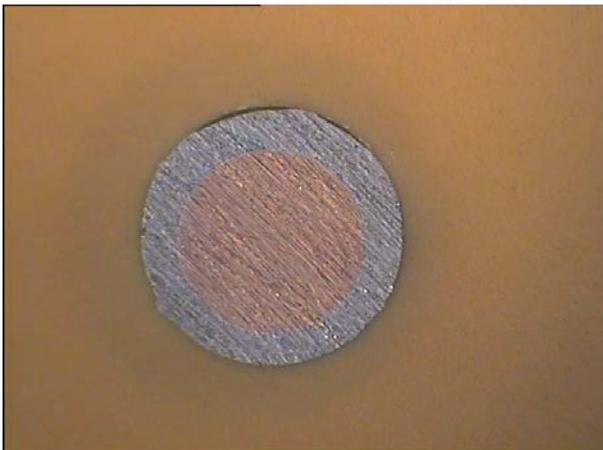
Fig 26

Close-up of Surface Section of Array
No. 1 showing absence of damage to
ceramic

One effect that can be seen from the surface sections above is that of solder / termination pull – away from the bore of the ceramic. This has the same effect as the cracks in gold plated parts, introducing a section of air dielectric within the capacitor build.

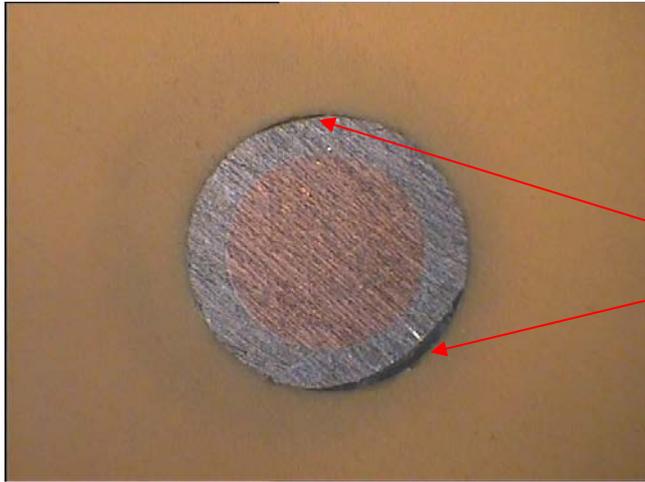
Fig 27

Second Close-up of Surface Section of Array No. 1 showing absence of damage to ceramic, but evidence of pull away of solder / termination from ceramic surface.

It is our conclusion that the unacceptable capacitance drop is caused by the failure of the termination / ceramic bond when exposed to excessive stress force as the solder / pin joint cools.

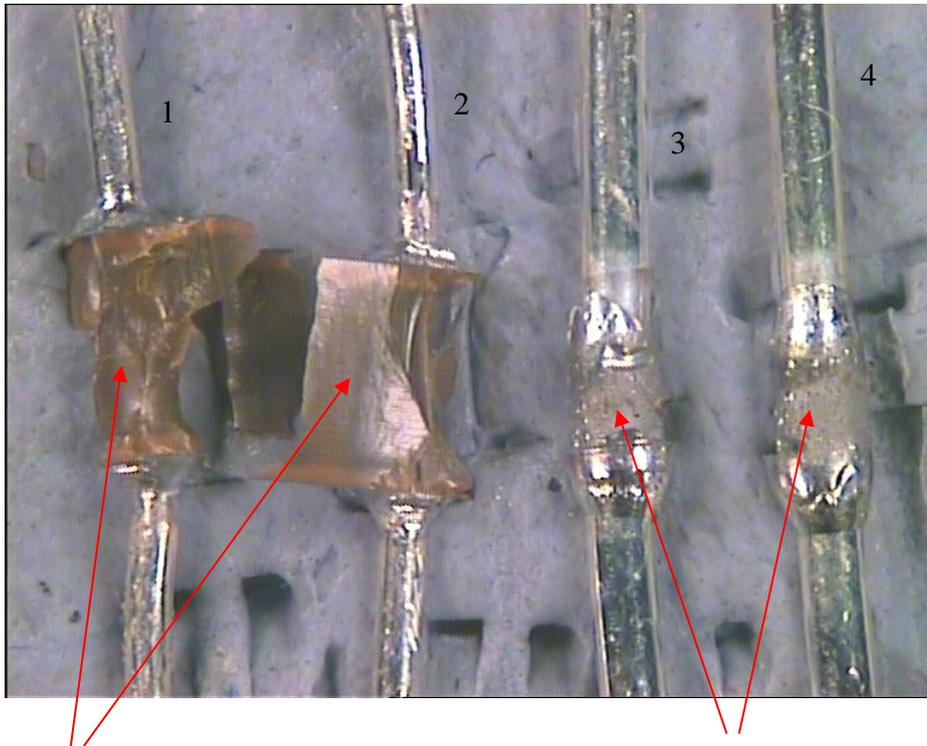
Fig 28

Silver plated copper pins soldered into planar array capacitors using 95.5Sn/3.8Ag/0.7Cu solder and removed by simply pulling out using a pair of pliers.

Pins 1 & 2 have been pulled from an array terminated with gold plate.

Pins 3 & 4 have been pulled from an array terminated with PdAg fritted termination.

Fractured ceramic remaining attached to the feedthrough pin after attempting to pull the pin out.

On closer inspection its possible to see the internal electrode structure of the capacitor.

Both demonstrate the characteristic shape of the longbow / comma crack in the way the ceramic fractured

Remains of PdAg termination can be seen on the otherwise 'clean' solder joint on pins 3 & 4

As can be seen above, the gold plated termination has a far greater adhesion to the ceramic, demonstrated by the amount of ceramic material still attached to the pin. By comparison, the PdAg termination has been cleanly removed from the ceramic with no ceramic material removed. Pins 3 and 4 do show the PdAg termination still attached to the solder – identified by the dull grey areas on the solder.

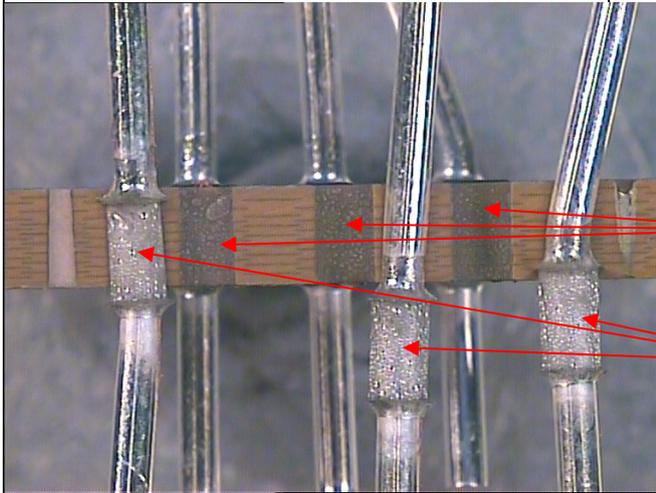
Fig 29

Example of PdAg terminated planar array capacitor soldered with 95.5Sn/3.8Ag/0.7Cu solder.

As the component is sectioned, the pins can be easily removed without damage to the ceramic.

Note the dark grey on the solder joint – this is the termination, which has been removed along with the pin & solder.

The ceramic exhibits no damage, and the pins are very easily removed – the termination has relatively little adhesion to the ceramic.

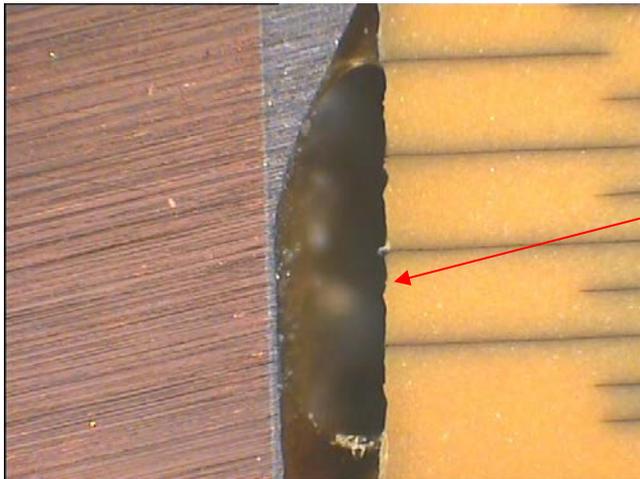
Fig 30

Termination leached away from this area.

These electrodes have lost contact and will result in a potential reduction in filtering performance.

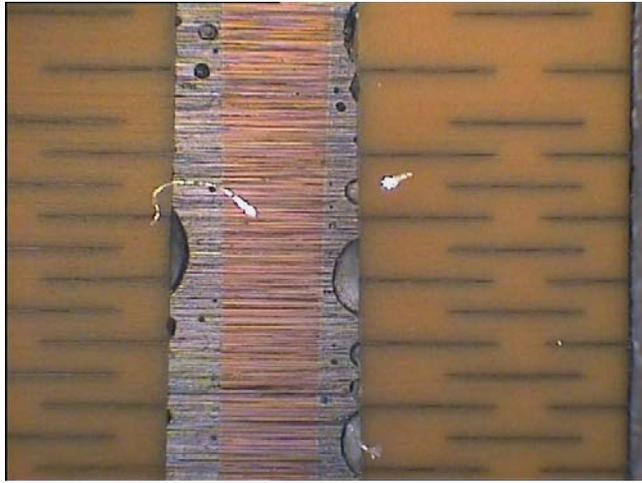
Fig 31

Further example of leaching and poor solder joint with PdAg termination.

This leaching also has the effect of reducing the termination adhesion between the termination and the ceramic.
