Knowles (UK) Limited
Chapman Way
Hethel, Norwich, Norfolk
NR14 8FB England

Solder Alloy Choice for Through Hole Ceramic Discoidal & Planar Array Capacitors

Application Note
Reference No: AN0011
Solder Alloy Choice for
Through Hole Ceramic
Discoidal & Planar Array
Capacitors Issue 10

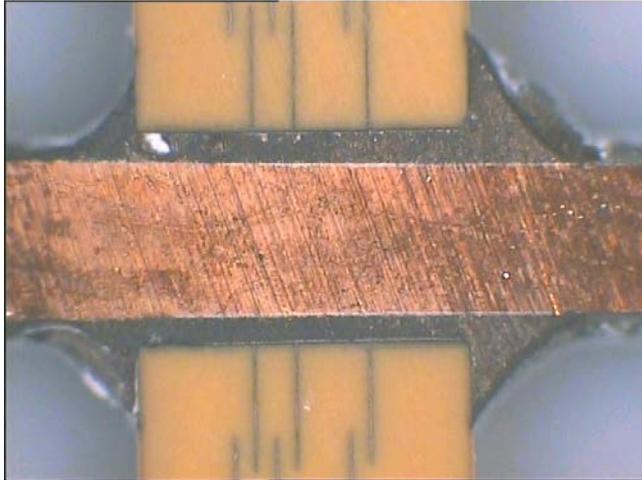
Fig 18

None of the joints sectioned exhibited any sign of induced cracks in the ceramic.

Example of force cooled
50Pb/50In solder joint
showing absence of any
cracks

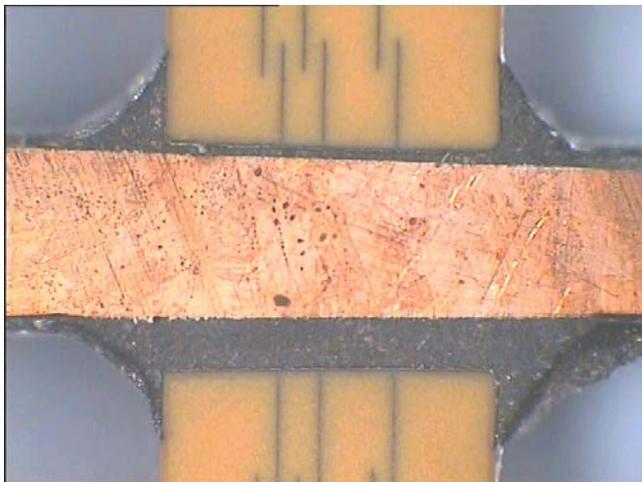
Fig 19

None of the joints sectioned exhibited any sign of induced cracks in the ceramic.

Example of 50Pb/50In solder
joint showing absence of any
cracks

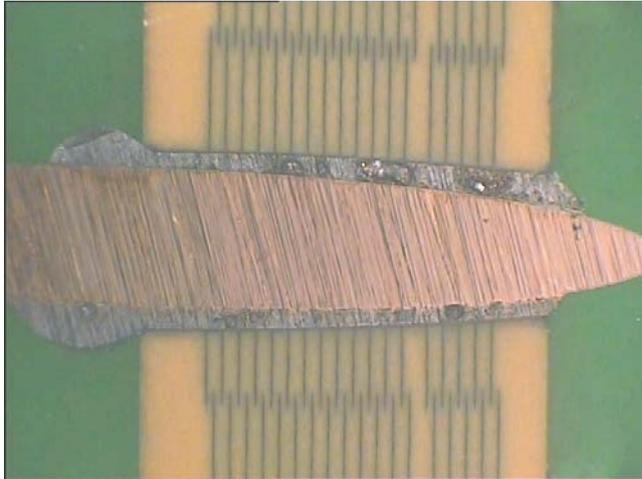
Fig 20

None of the joints sectioned exhibited any sign of induced cracks in the ceramic.

Example of force cooled
95Pb/5In solder joint showing
absence of any cracks

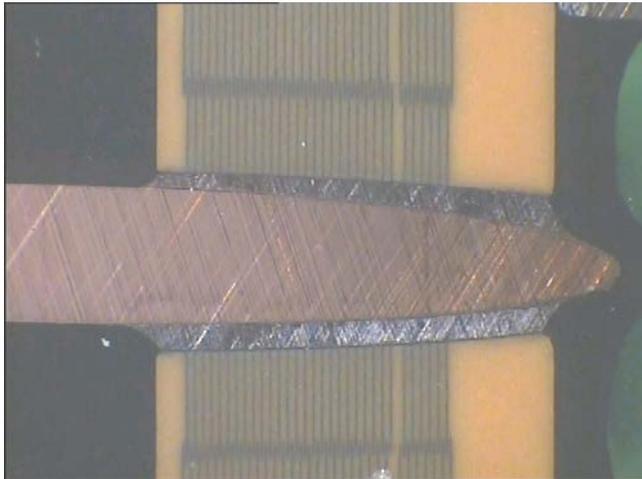
Fig 21

None of the joints sectioned exhibited any sign of induced cracks in the ceramic.

Example of 95Pb/5In solder
joint showing absence of any
cracks

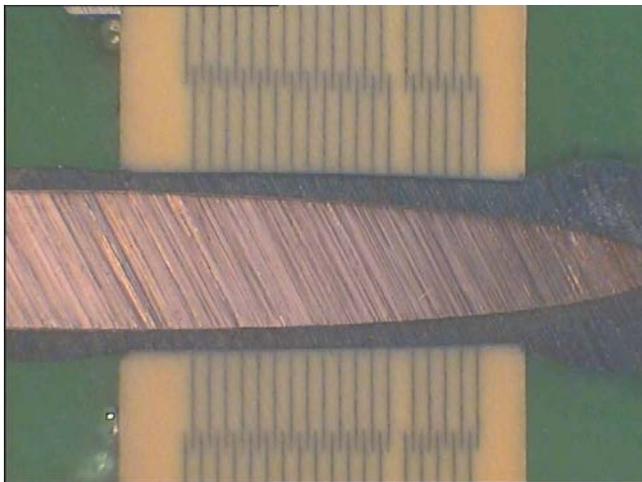
Fig 23

None of the joints sectioned exhibited any sign of induced cracks in the ceramic.

Example of 93.5Pb/5Sn/1.5Ag solder joint showing absence of any cracks

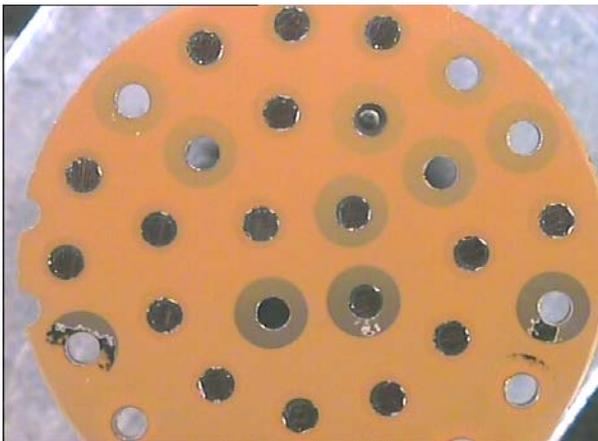
Fig 25

Surface sectioning of both arrays found no ceramic cracks.

Surface Section of Array No. 2
showing absence of damage to
ceramic
